Notice for service campaign for SUBARU R1700i and R1100

Service campaign of portable generators R1700i and R1100
which is produced by Fuji Heavy Industries Ltd.

— Possibility of fuel leakage —

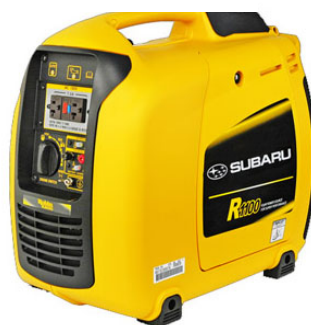
R1700i

If these generators are used without sufficient ventilation, e.g. in small cabinets, caravans etc. for a long time, there is a possibility that the outlet nipple of the fuel tank may incur small cracks due to the unusually high temperature inside the generator. In very rare cases, this may result in a fuel leakage from the crack. Throughout Europe, only one case has occurred so far. Even though this risk occurs only in cases of misuse of these products and where the users do not adhere to the safety instructions contained in the owner's manual, for reasons of safety Fuji Heavy Industries Ltd. asks its customers to have the fuel tank exchanged.
